Boone Lake

Exeter, RI

General Native Vegetation Assemblage

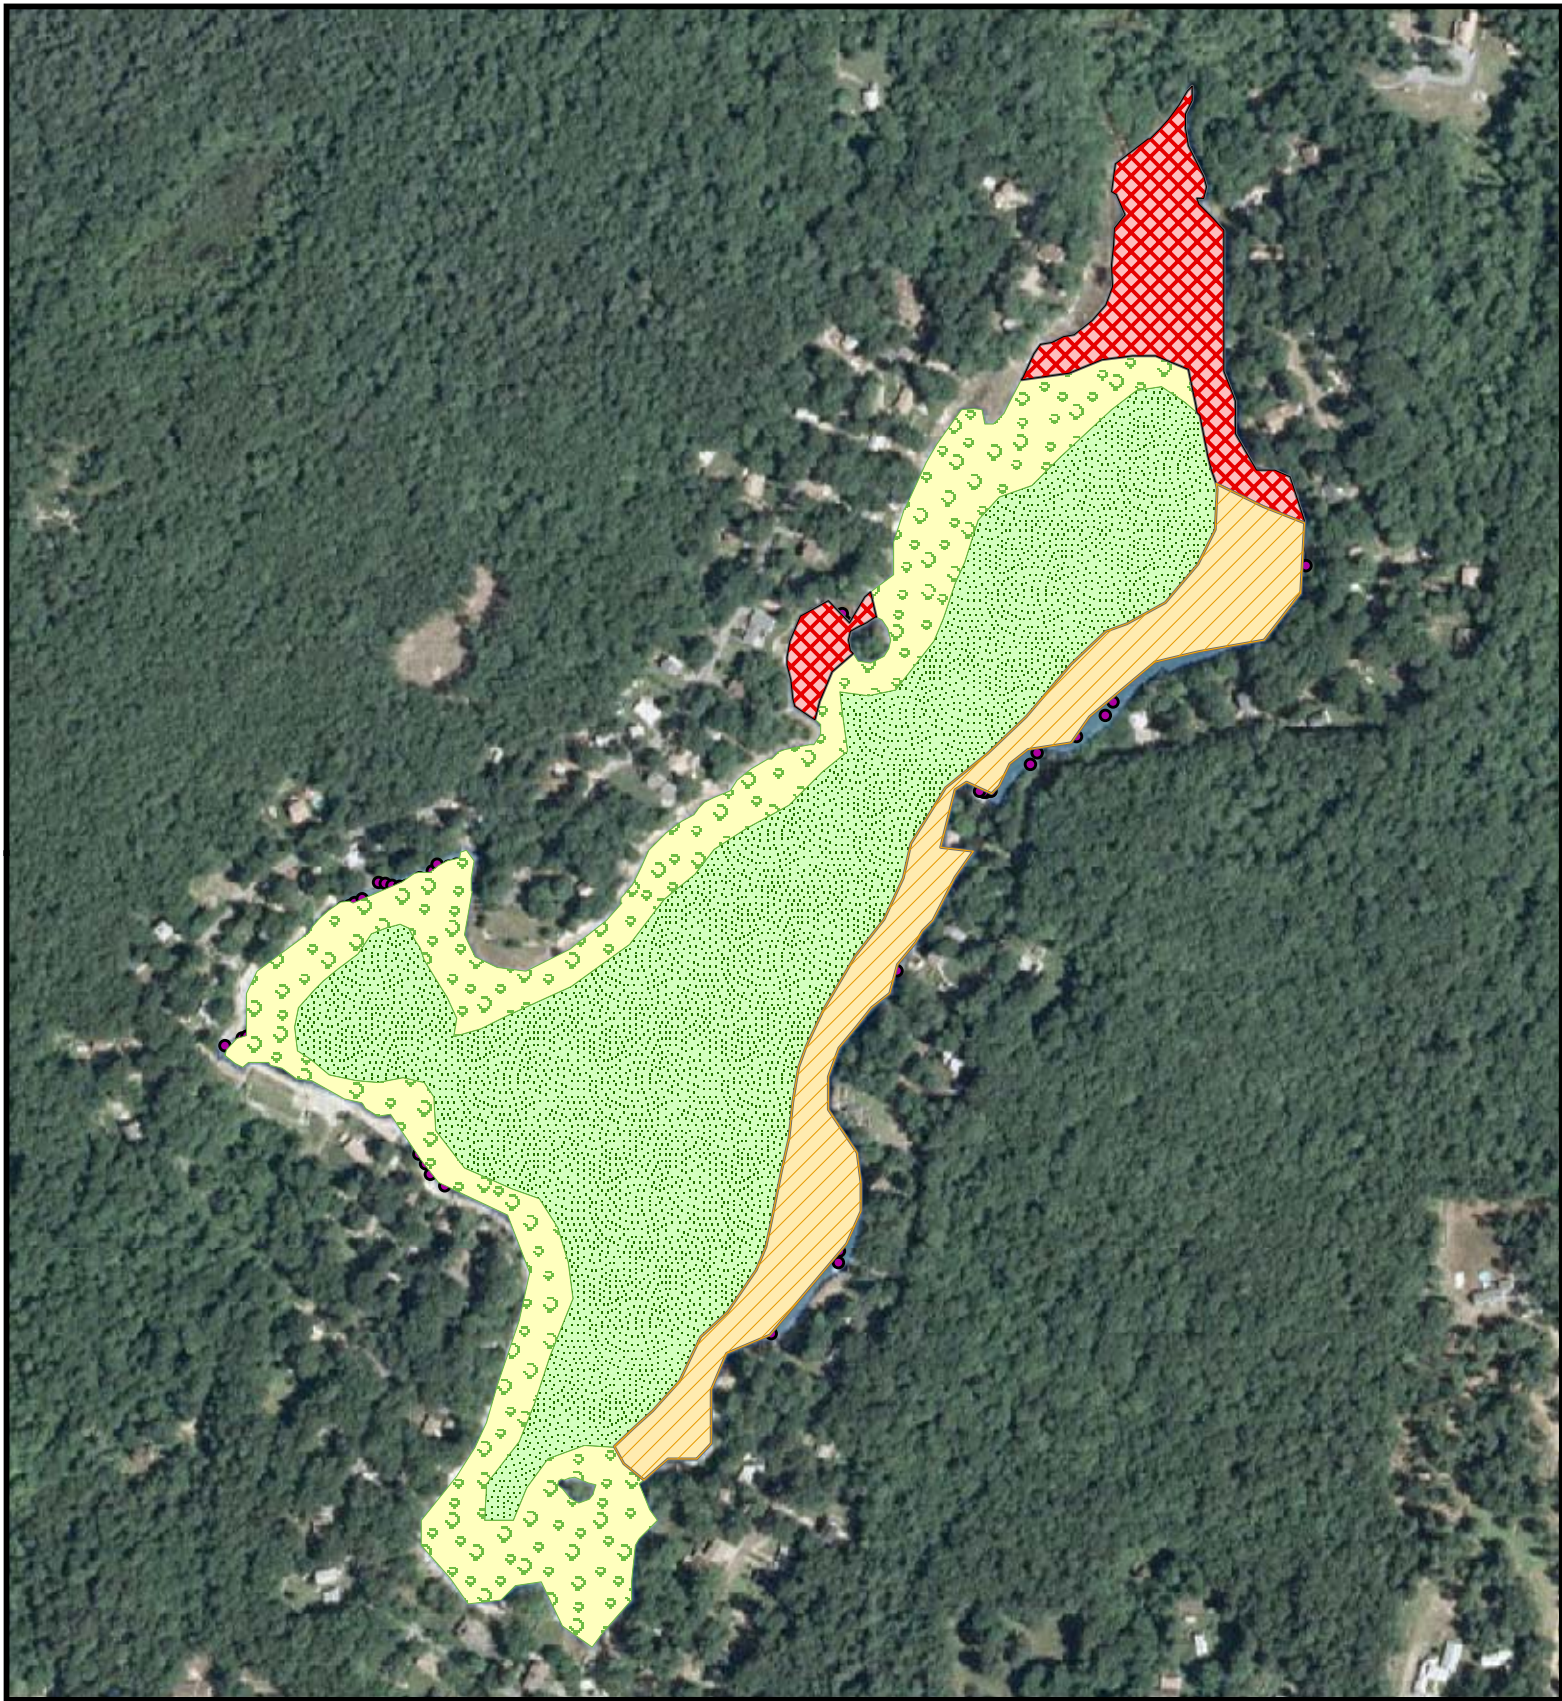
| FIGURE: | SURVEY DATE: | MAP DATE: |
|---|---|---|
| 1 | 8/11/09 | 8/27/09 |

Moderate vegetation cover dominated by thinleaf pondweed and Nitella with patches of bladderwort, ribbonleaf pondweed, white lilies, and spike rush and with scattered quillwort plants throughout.
-

Dense covering of vegetation dominated by bladderwort, thinleaf pondweed and snailseed pondweed at the surface
-

Low density vegetation dominated by Nitella, with scattered quillwort and patched of tape-grass, ribbonleaf pondweed and snailseed pondweed
-

Largely unvegetated with widely scattered nitella

Note: Milfoil distribution not pictured. Please see figure 3
